# LITTLE SWAN LAKE WATERSHED MANAGEMENT STUDY

Little Swan Lake  
Warren County, Illinois

October 2018

## KLINGNER & ASSOCIATES, P.C.

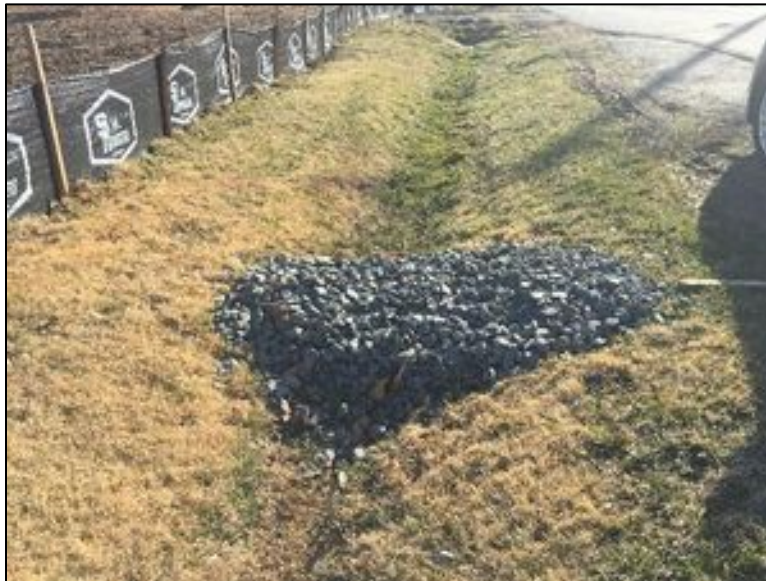
Figure 1. Example Rock Check Dam ([https://stormwater.pca.state.mn.us/index.php?title=Sediment\\_control\\_practices\\_-\\_Check\\_dams\\_\(ditch\\_checks,\\_ditch\\_dikes\)\)](https://stormwater.pca.state.mn.us/index.php?title=Sediment_control_practices_-_Check_dams_(ditch_checks,_ditch_dikes))))

- 1.) Rock (Riprap) Check Dams in the small ditches and swales leading to the lake
  - a. Check dams help reduce ditch and channel velocities, prevent erosion, and trap sediments. They do this by creating low velocity areas upstream of each dam causing heavier sediments to drop out of suspension. Check dams are relatively inexpensive and easy to install and maintain. Check dams should only be installed in areas where the channel slope does not exceed 10% and the contributing watersheds do not exceed 10 acres. Height, width, spacing, and other design considerations will be dependent on specific site conditions.

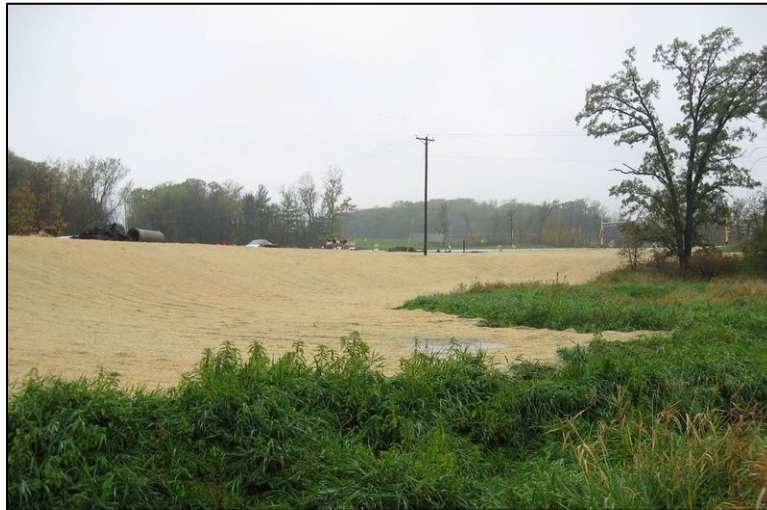
Figure 3. Example of properly applied mulch at a construction site  
([https://stormwater.pca.state.mn.us/index.php?title=File:Mulch\\_stabilized\\_slope\\_2.jpg](https://stormwater.pca.state.mn.us/index.php?title=File:Mulch_stabilized_slope_2.jpg))

Construction activities can be a major source of sediment. By applying and strongly enforcing lakeshore construction rules, preventable and unnecessary siltation of the lake can be significantly reduced. Properly managed construction sites can reduce sediments 75 to 99 percent over construction sites that apply no erosion control measures.

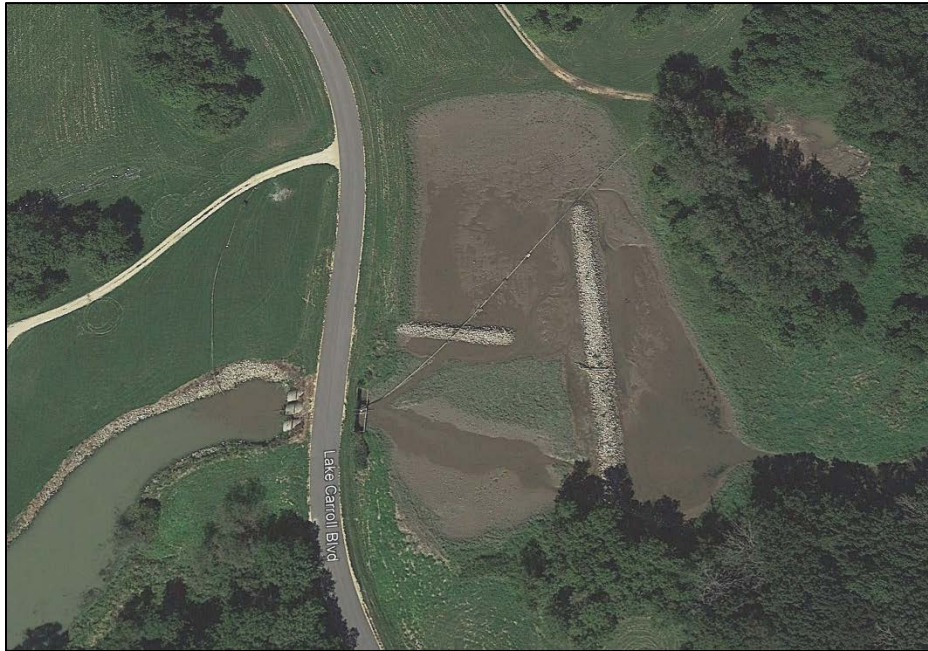
Figure 5. Sediment Basin Located on a Large Lake in Rural NW Illinois – Aerial View

Similar to wetlands, sedimentation basins are a very effective way to reduce and control the amount of sediments entering the lake. They act as impoundments which store water and allow sediments to fall out of suspension prior to entering the main body of the lake. Figures 5 and 6 below show the application of a sediment basin on a similar lake in Northwestern Illinois.

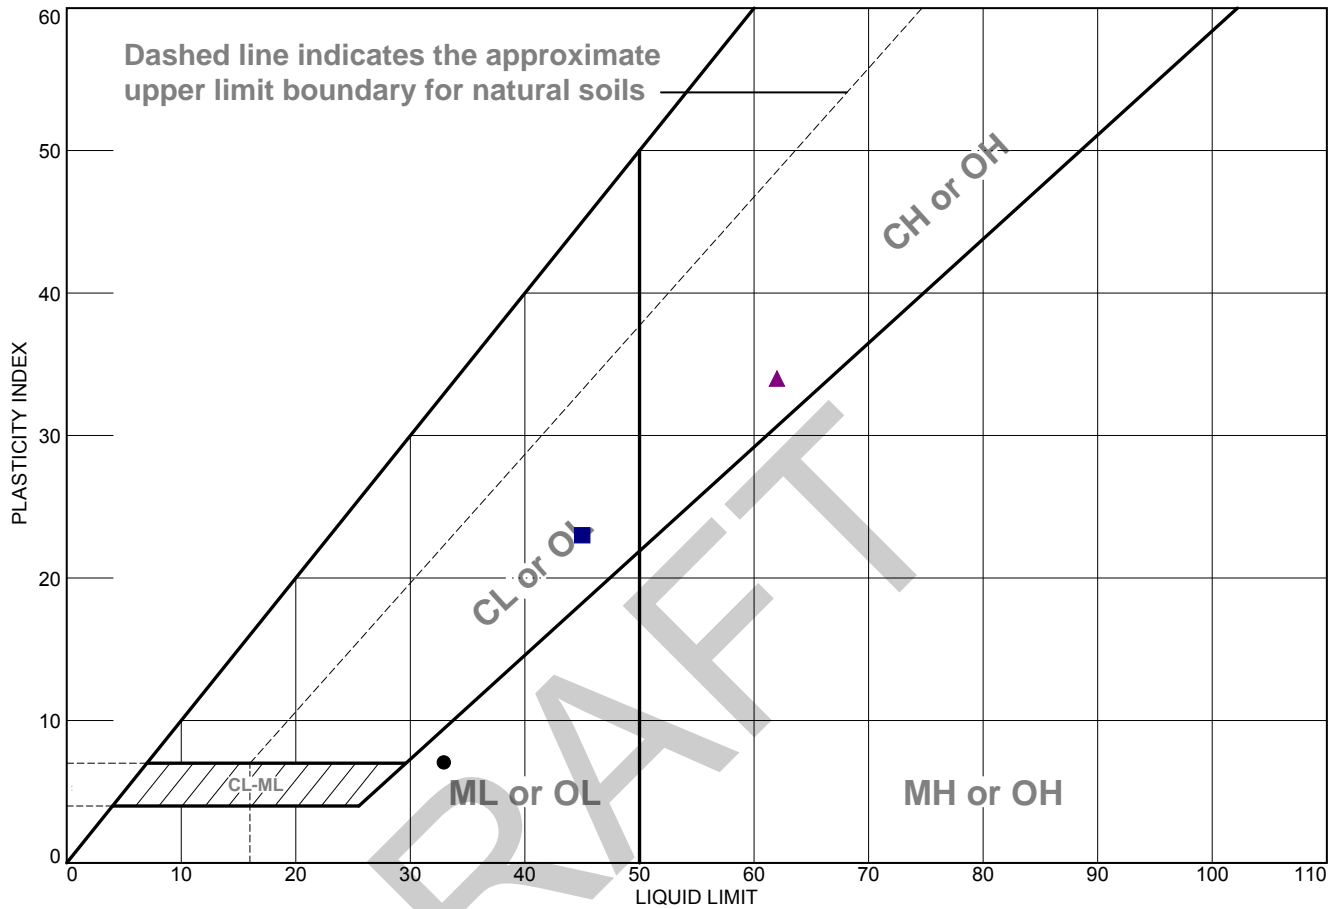
## ATTERBERG LIMITS TEST REPORT (ASTM D4318)

MATERIAL DESCRIPTION	LL	PL	PI	%<#40	%<#200	USCS
●	Silt with Sand (ML), Brown mottled Gray	33	26	7	98	84	ML
■	Lean Clay (CL), Gray, Silty	45	22	23	99	97	CL
▲	Organic Clay (OH), Brown mottled Gray, Silty	62	28	34	100	99	(OH)

**Remarks:**  
 ● As Rec'd Moisture = 25.7%  
 ■ As Rec'd Moisture = 34.1%  
 ▲ As Rec'd Moisture = 90.9%

The Atterburg Limits Test determines the material classification of the sediments which, in turn, helps dredging contractors understand what types of materials are to be removed. The sediments found at the bottom of Little Swan Lake were different at the three different sample locations. The first was Silty Sand (ML), the second was Lean Clay (CL), and the third was Organic Clay (OH). While distinctly different, these soil types are not unexpected for a man-made lake bottom. Silts and Clays have very small particle sizes which are able to settle out when the watershed’s tributaries enter the lake and the water velocity drastically decreases. These soil types are also common in the watershed, and we expect to see similar soil types in the watershed as we would the lake bottom.

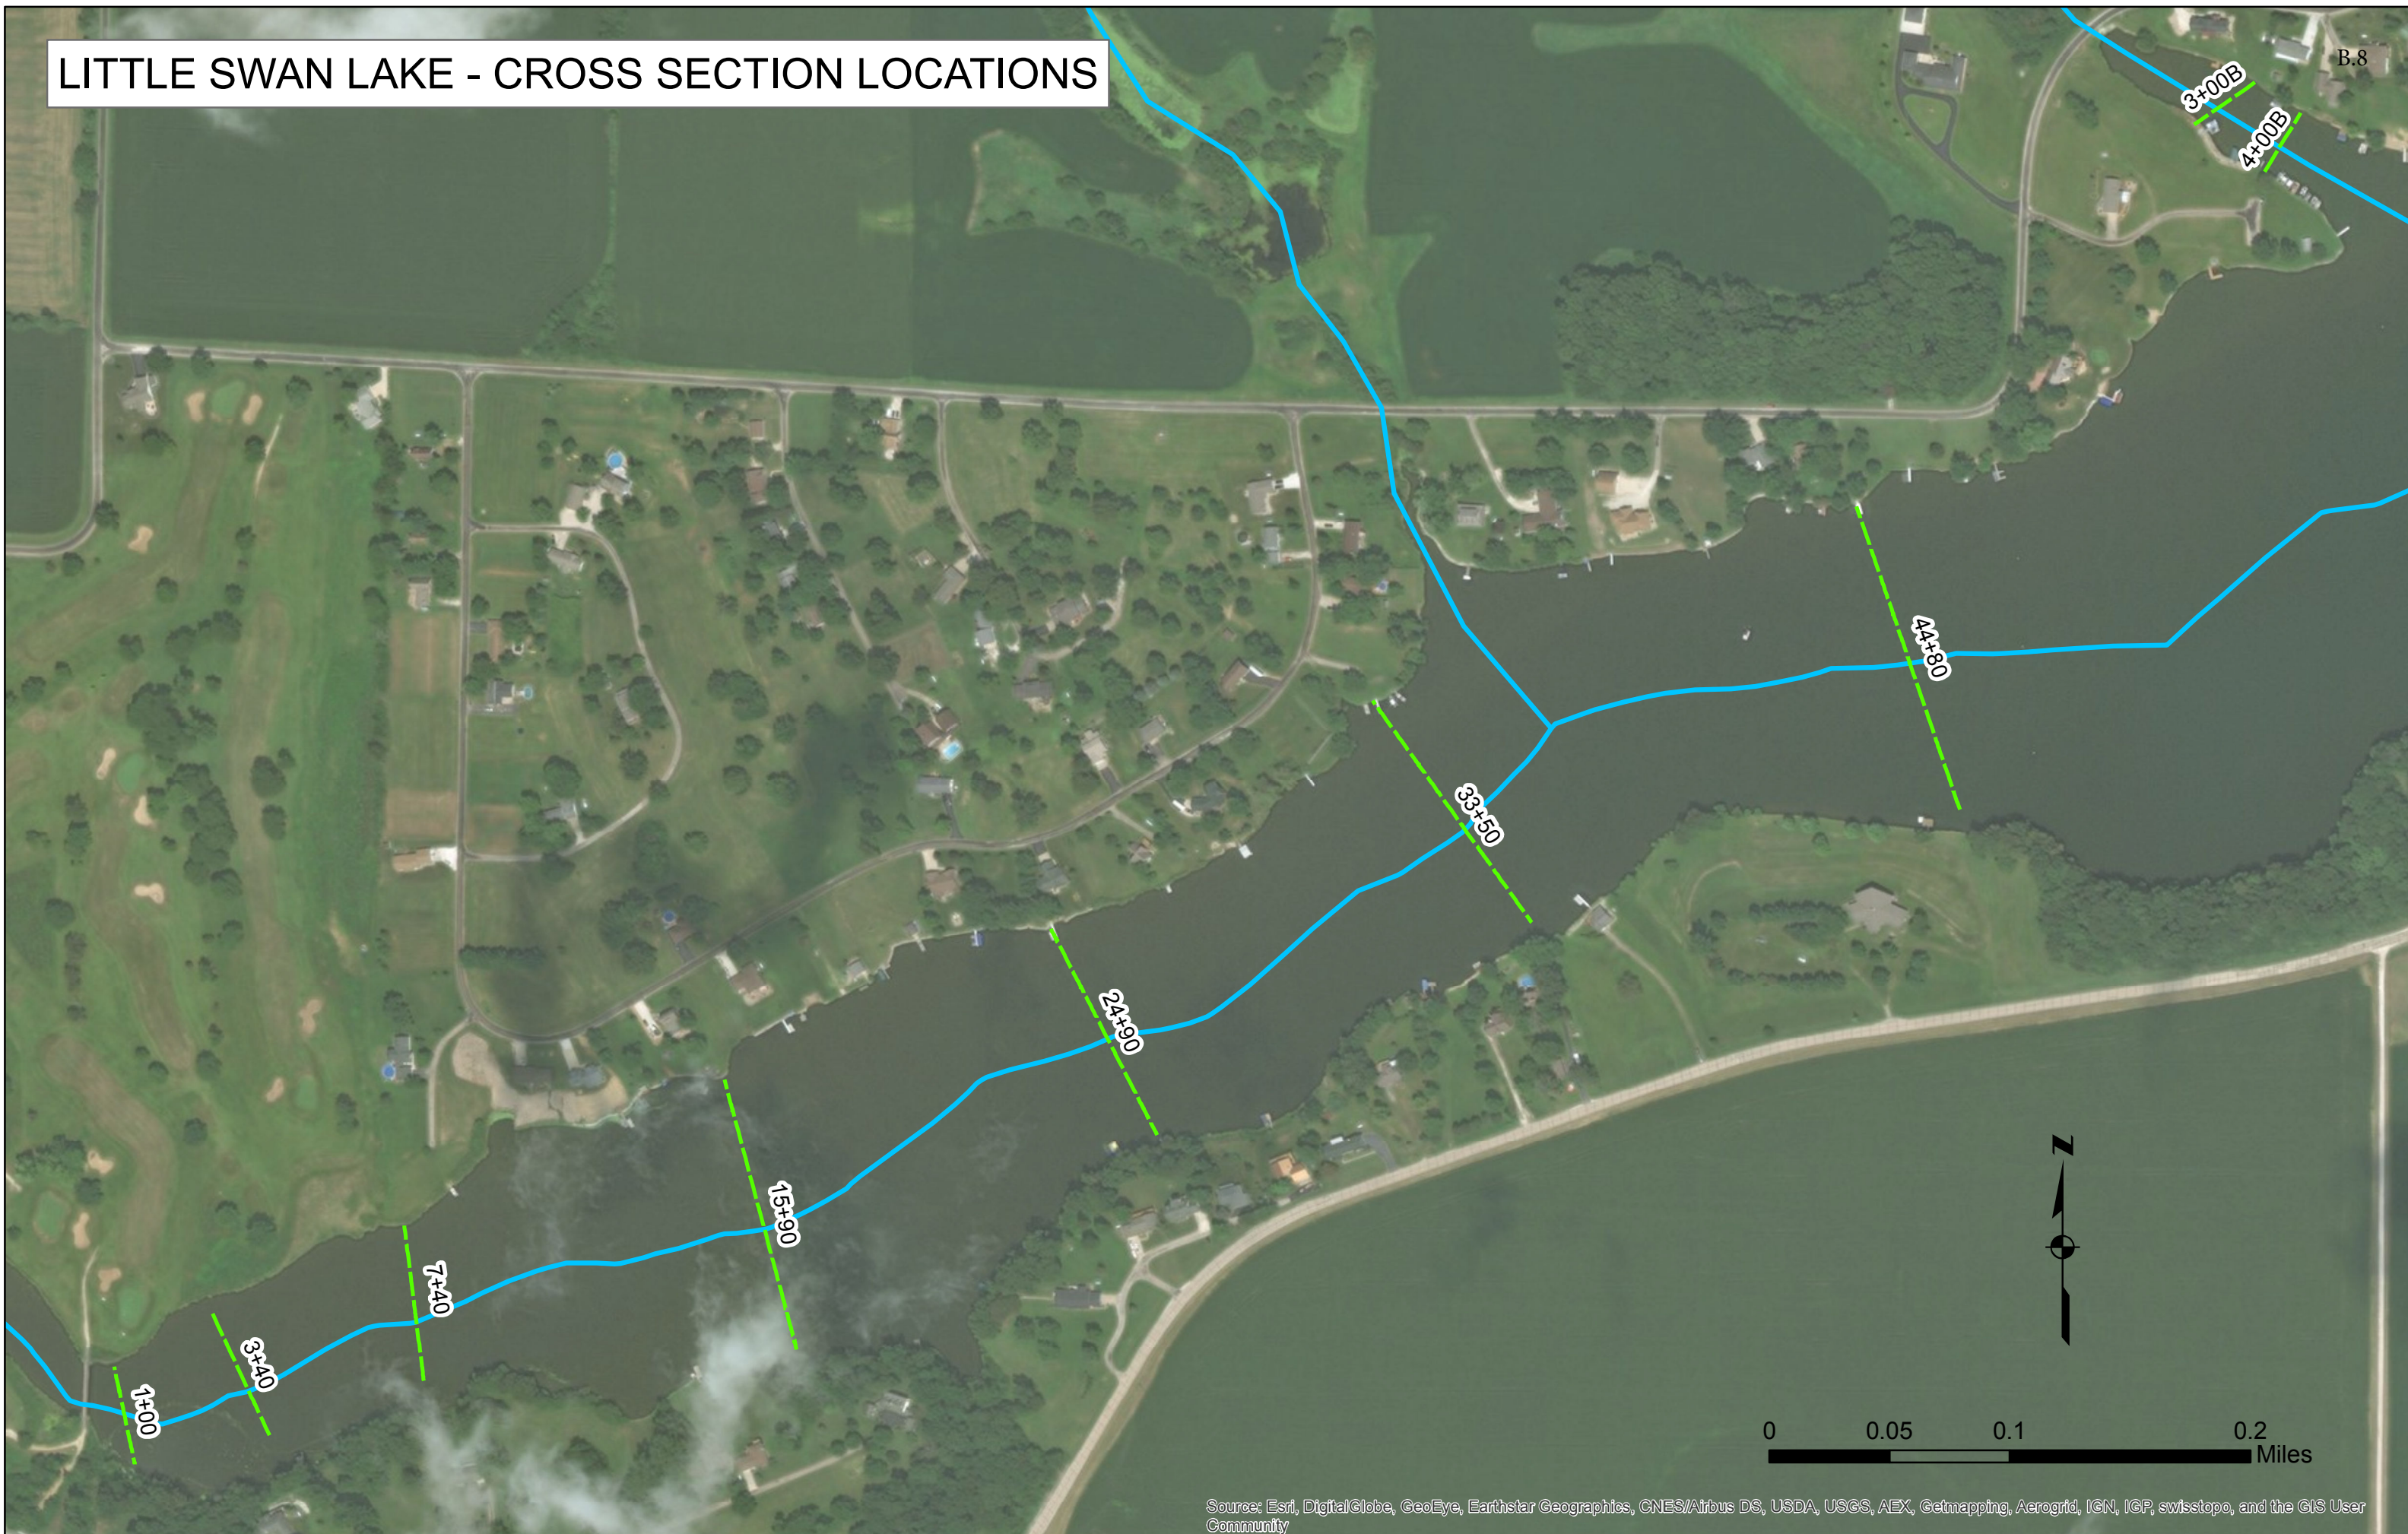
B.8

# LITTLE SWAN LAKE - CROSS SECTION LOCATIONS

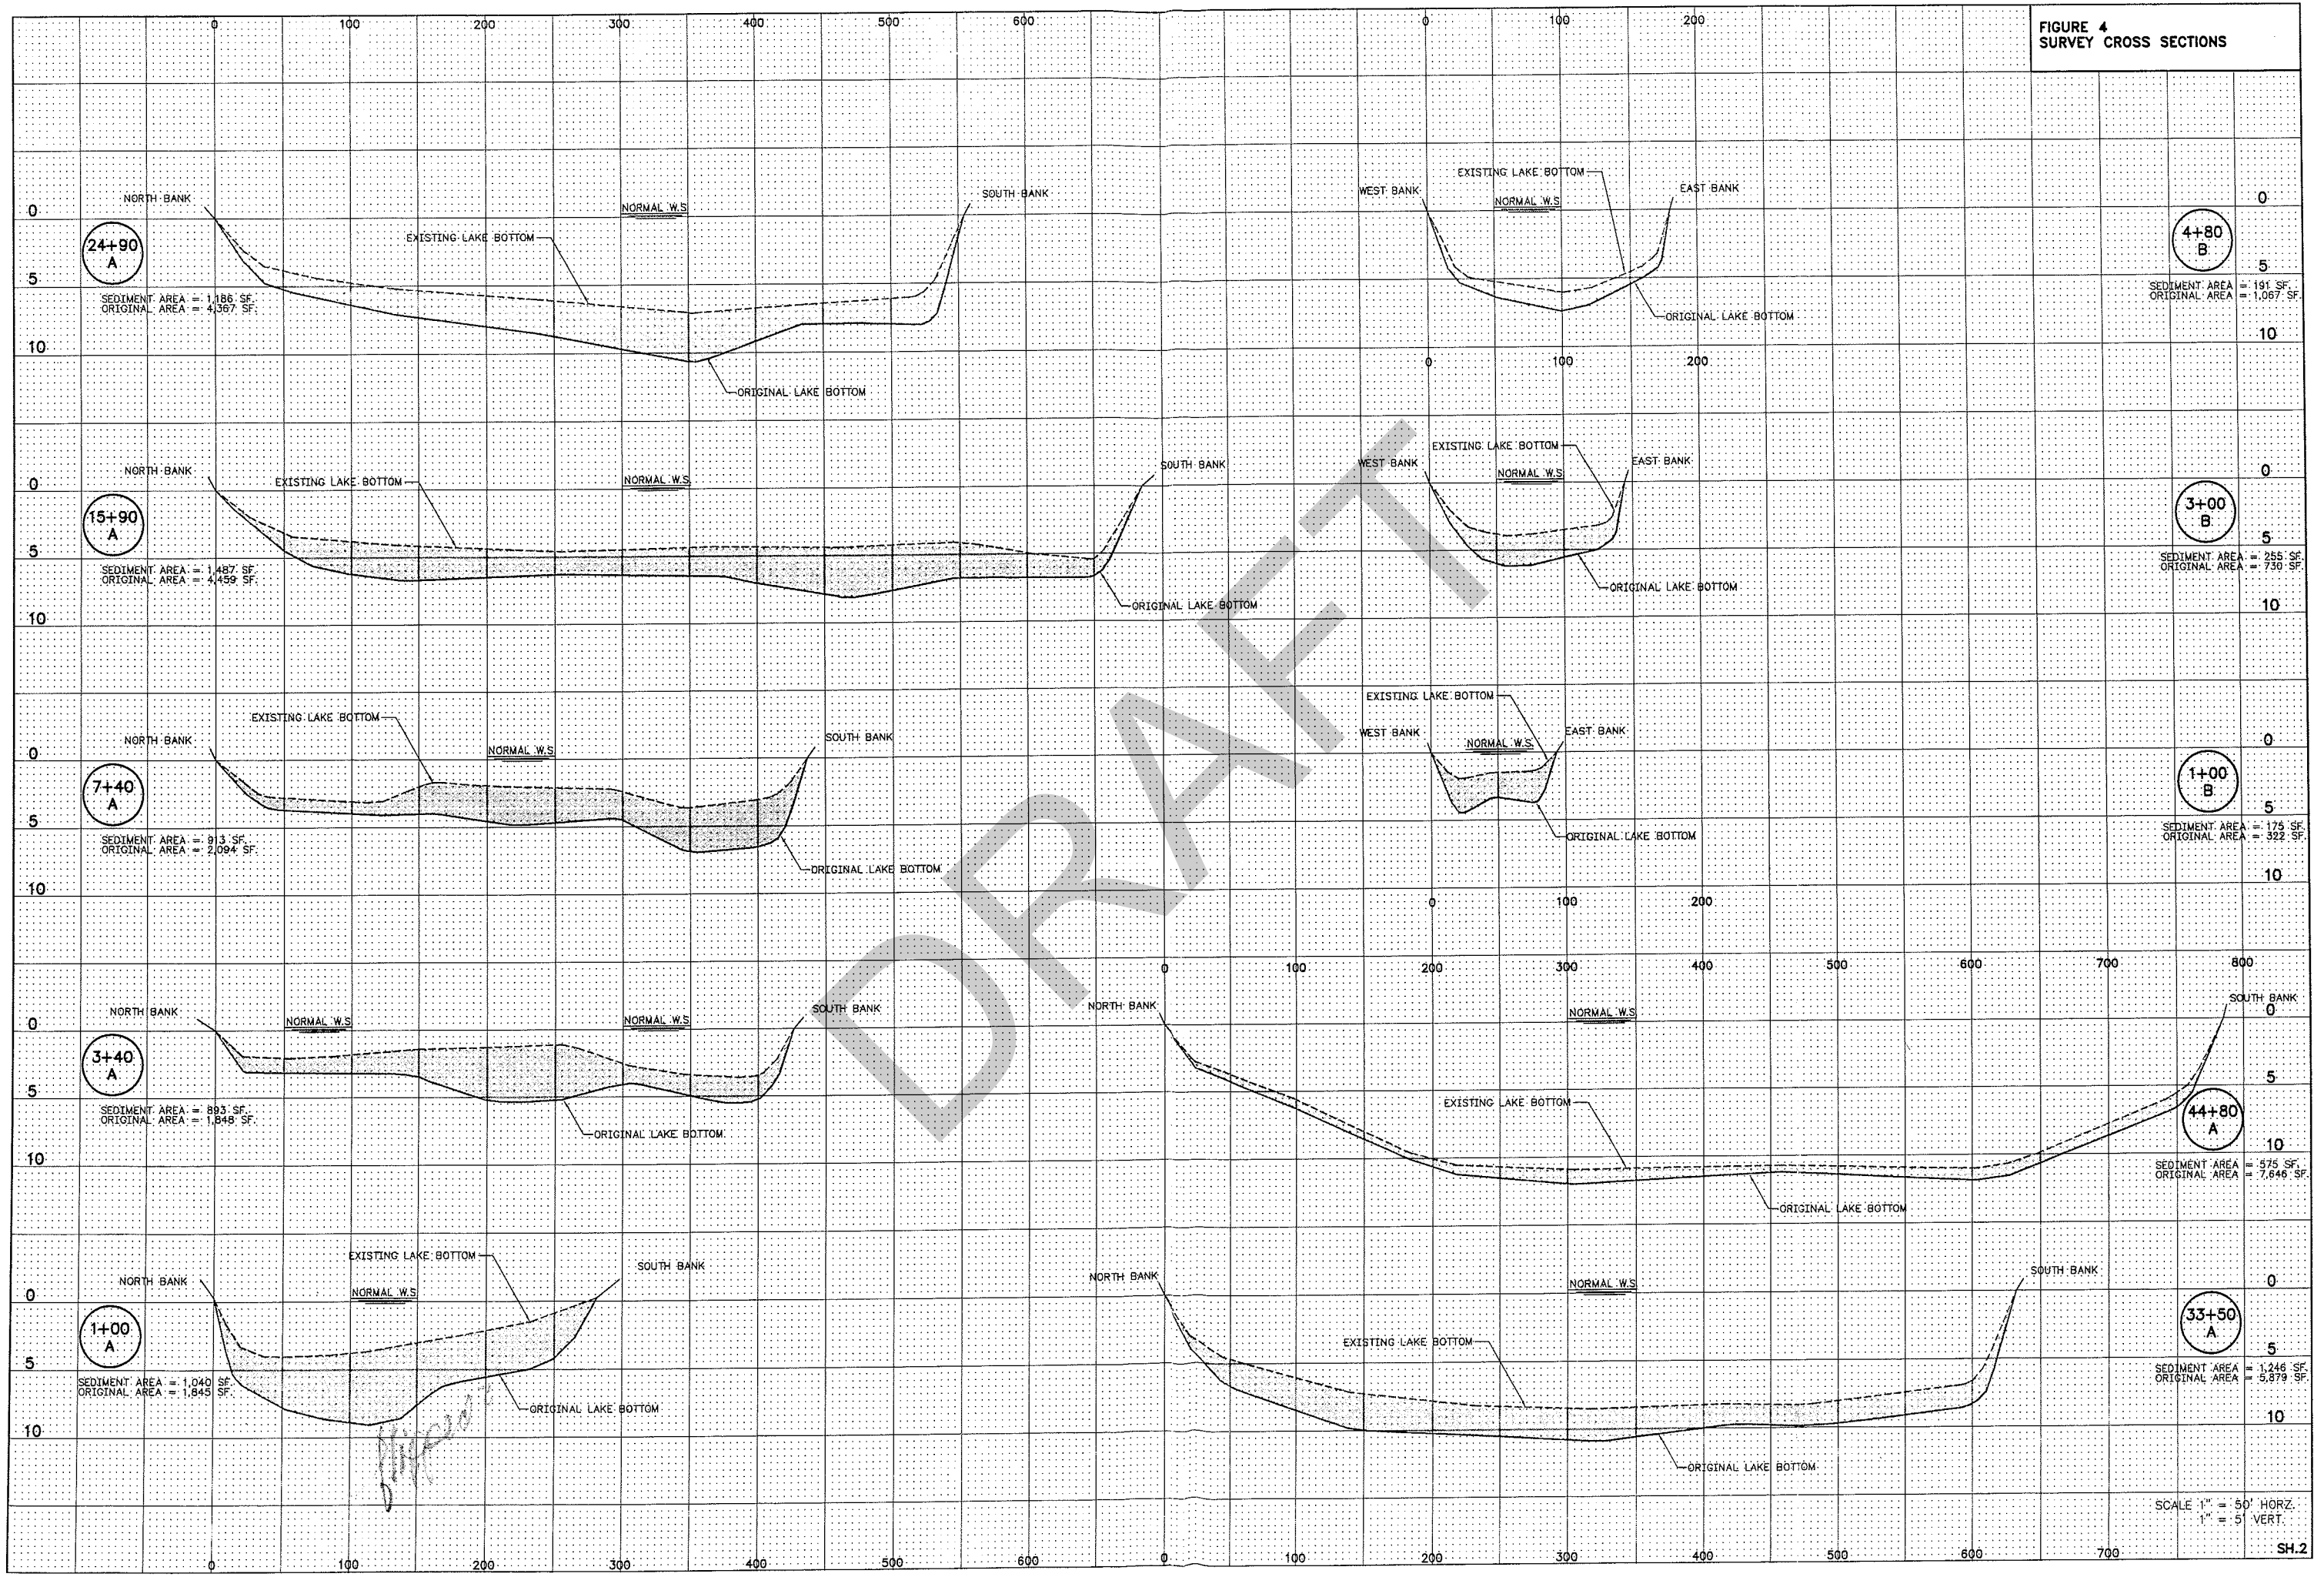
FIGURE 4  
SURVEY CROSS SECTIONS

The results of the sedimentation Survey show that sediment deposition has been greatest in the upper end of the lake where Little Swan Creek enters at the golf course bridge and gradually decreases east of the inlet point. Lake segments #1 and #2 have lost more than 50 percent of their original water depth and segments 3 through 8 have lost gradually decreasing percentages. This gradually sloping delta deposit is typical of reservoirs with predominantly silt and clay sized sediment particles, which is directly related to water velocity, particle size and settling rates.
